## 2020 Sulphur cap Experience so far

Antonis Trakakis  
*Technical Director, Marine*

**Annual Conference HIMT**

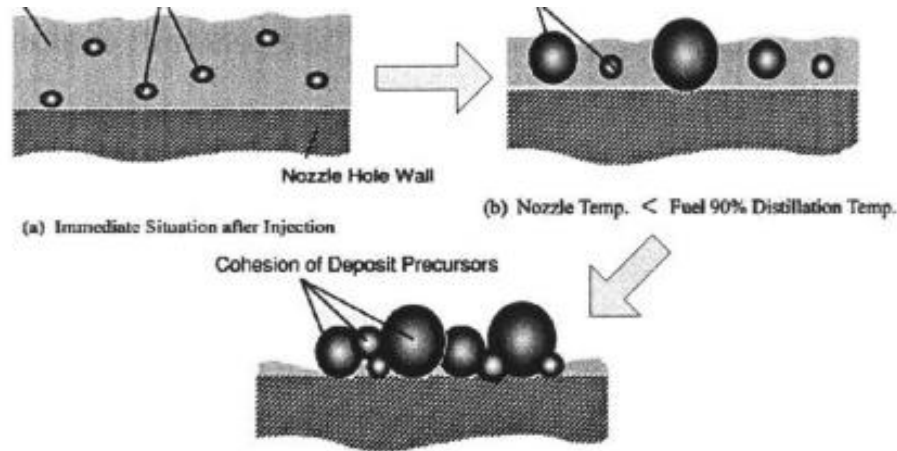
# Formation of deposits on fuel nozzles

When the local temperature is close to the distillation temperature of the fuel, most of the distillate part evaporates and deposit precursors (asphaltenes) cohere on the surface of fuel injector nozzle, and it is very difficult to be washed away
